## LABORATORY REPORT

Title: Explosion Investigation at Maldives;  
 Foreign Police Cooperation-  
 Technical Assistance Request

**THE FOLLOWING ITEMS WERE RECOVERED FROM THE MALDIVIAN GOVERNMENTAL VESSEL, THE FINIFEMA. AN EXPLOSION OCCURRED ON SEPTEMBER 28, 2015 ON THIS VESSEL IN THE HARBOR OF MALE, THE MALDIVES. THESE ITEMS WERE SUBMITTED UNDER COVER OF COMMUNICATION DATED OCTOBER 28, 2015, RECEIVED INTO THE LABORATORY ON OCTOBER 22, 2015 AND OCTOBER 27, 2015 AND ASSIGNED LABORATORY NUMBER 2015-02440.**

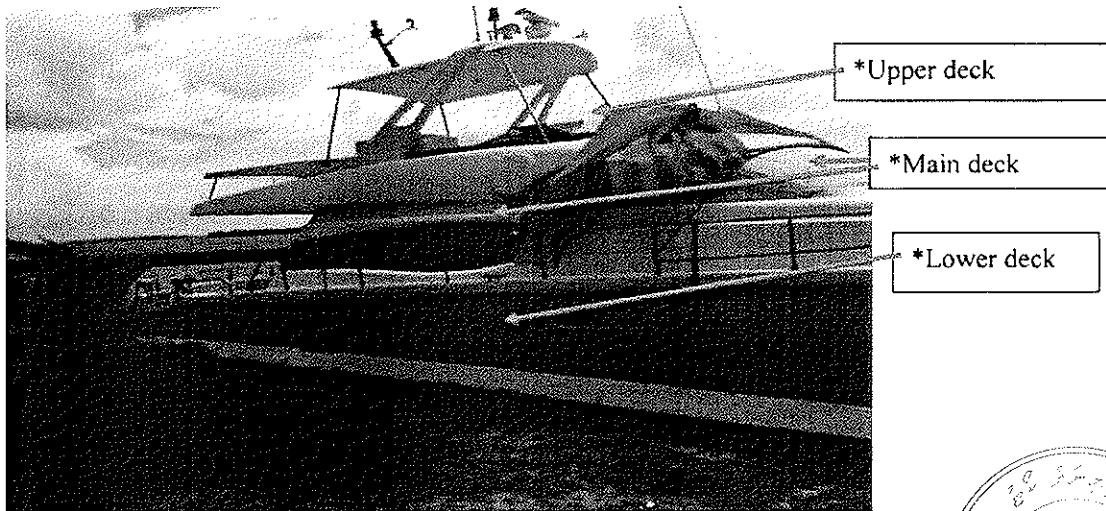
**Figure 1**

On September 28, 2015 an explosion occurred on an official Maldivian government boat (Figure 1) carrying the President of the Maldives and his entourage. The United States was asked to assist in the investigation of the explosion. The FBI Explosives Unit along with other FBI personnel conducted a post blast investigation on the boat.

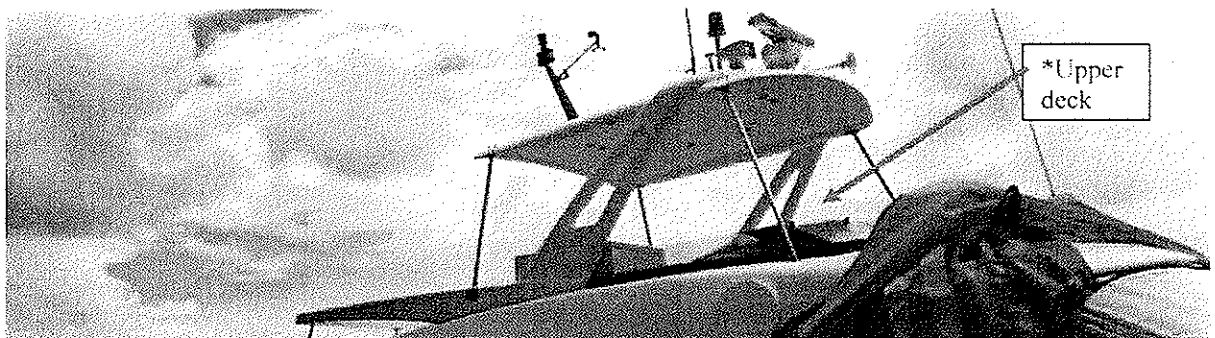
**Figure 2**

Figure 2 shows the upper deck level, outside bridge area which sustained no damage from the blast.

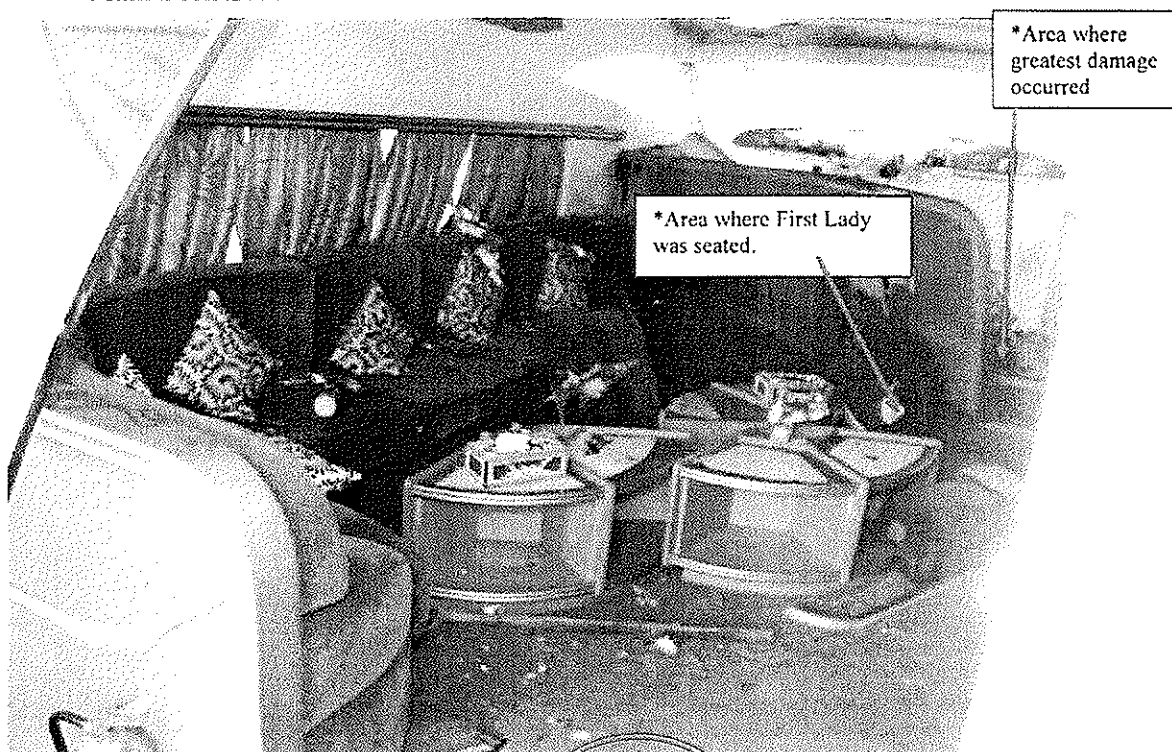
Figure 3

The First Lady was sitting on the couch as noted in figure 3 and figure 4, directly aft of the wall where the area of greatest damage occurred. She sustained several fractured vertebrae when the overpressure from the explosion threw her forward over the coffee table. Other injuries to personnel on the boat were reported as being minor.

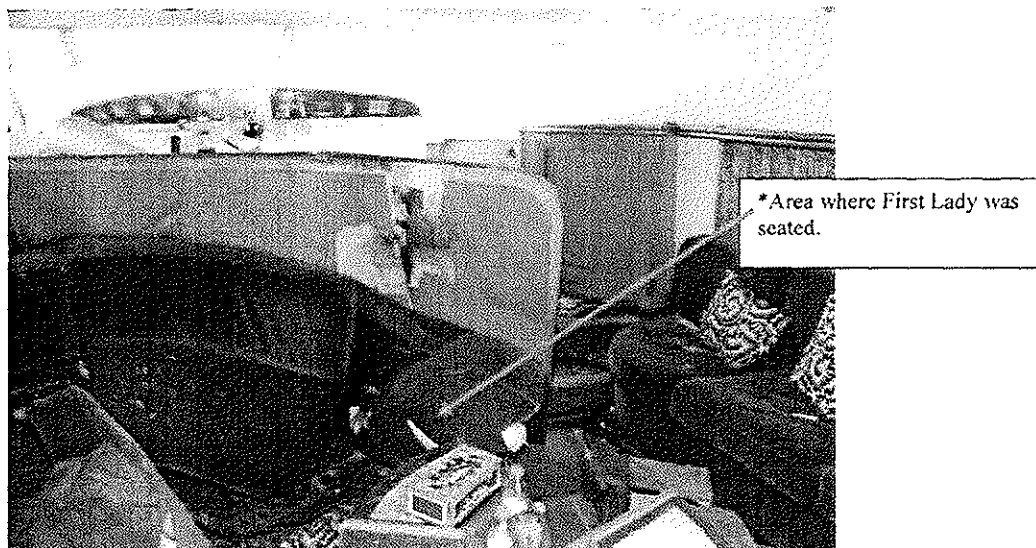
Figure 4

The main deck is the level where the explosion occurred, causing damage to the interior seating area and the box seat in the bridge area. The explosion damaged the half-wall between these two areas. No windows were shattered or broken during the blast. The rear sliding glass door was pushed off of its tracks and one window in the bridge area of the boat was slightly pushed out of its frame.

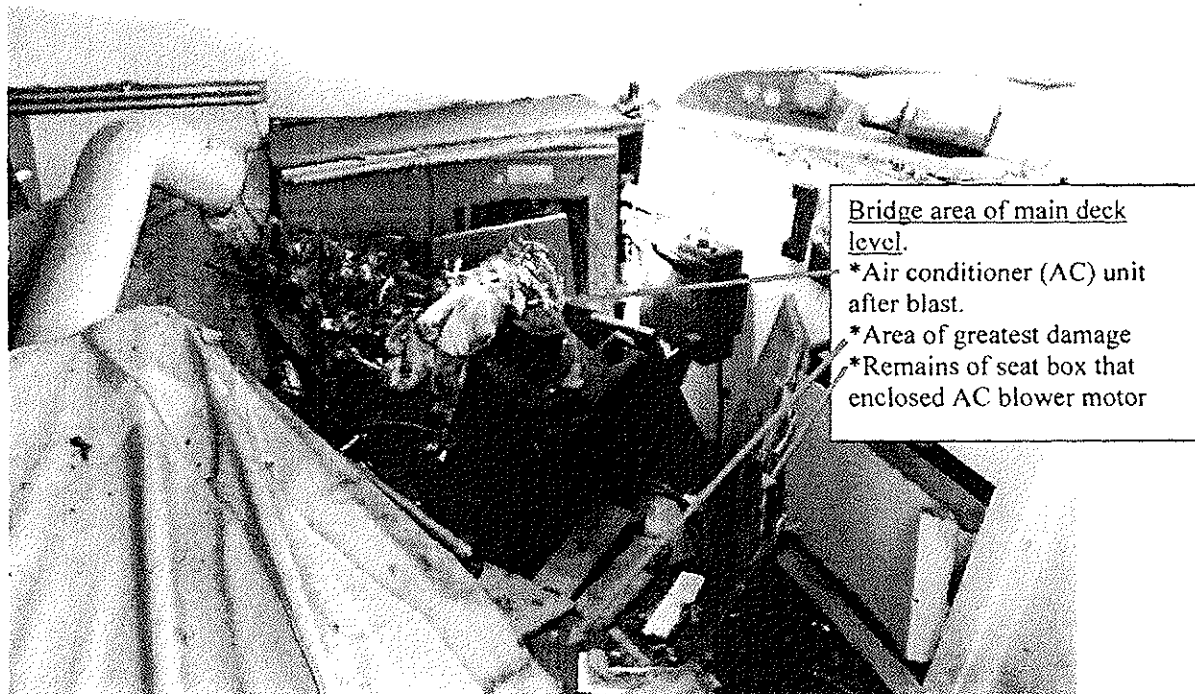
Figure 5 shows the area where the greatest damage occurred, located on the main deck level in the bridge area. The seat box that enclosed the air conditioner (AC) blower motor was destroyed by an explosion originating from within its interior. The AC unit was pushed up and sustained damage to its base plate frame and the fan motor housing. The flexible aluminum exhaust tube was destroyed.

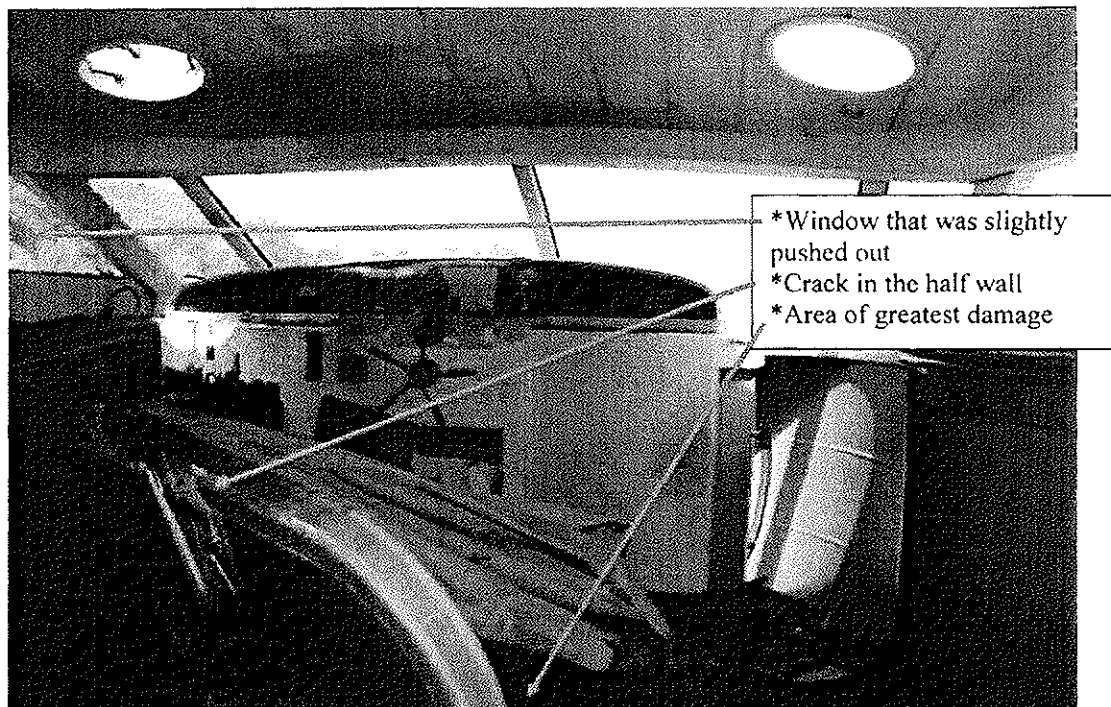
Figure 6 shows the cracked half-wall that is broken from its base along its entire length due to the explosion. The area of the crack in the wall is directly behind the area of greatest damage. The window shown above and in figure 13 below was slightly pushed out.

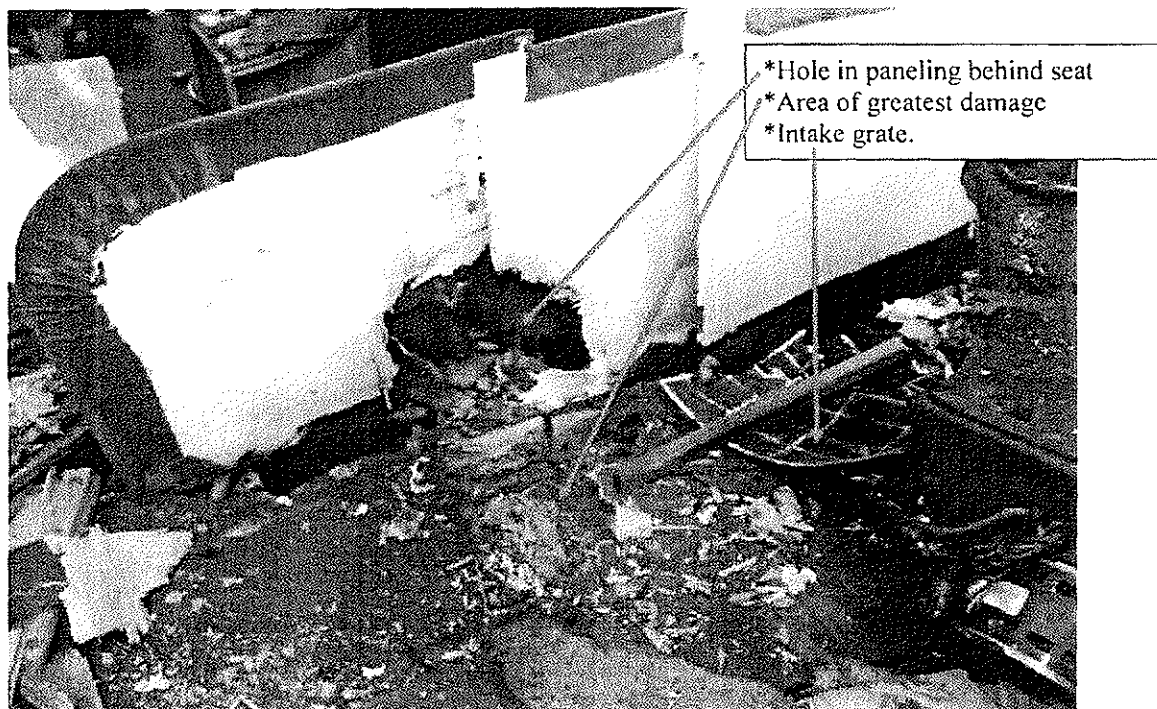
Figure 7

Shown in figure 7 is the area of greatest damage on the boat. As depicted in this photo, the wood paneling had been removed from the seat to expose the hole created by the overpressure. The intake grate, which was attached with screws to the box seat, allowed air to be taken in by the blower motor (see figure 13 for approximate location of the intake grate). This grate exhibited damage of being pushed outward from the seat by the overpressure from the explosion.

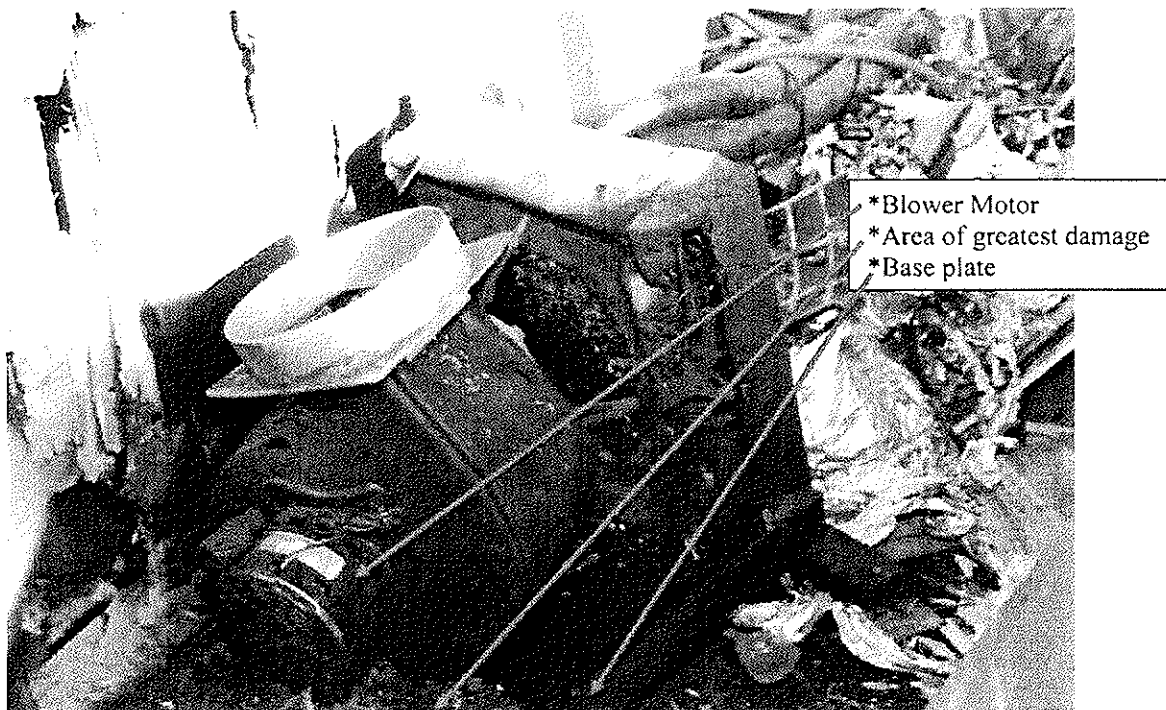
Figure 8 shows the blower motor and the base plate in the approximate location where they would have been before the explosion. Soot was visible on the blower motor and fan casing. (See figure 13 for further detail)

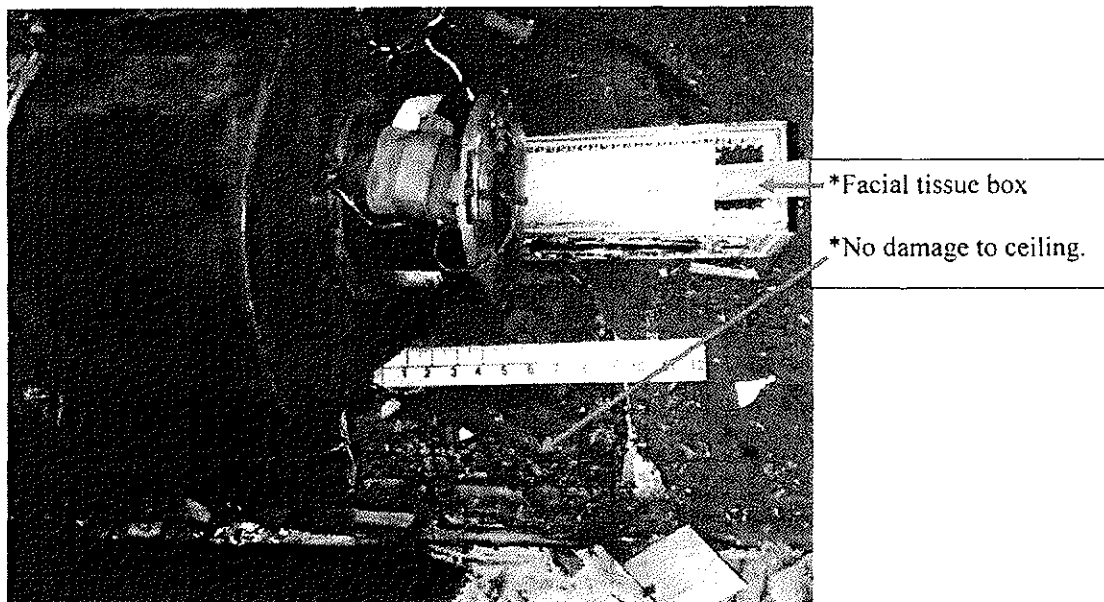
Figure 10 shows a facial tissue box utilized to support the blower motor for demonstration of its location. The area below the ruler shows that no damage occurred to the ceiling of the galley, even though this area is only approximately 2 inches below the area of greatest damage.

Figure 9 and figure 10 show the approximate size of the area of greatest damage. The approximate size of damage to the floor is 9" long x 10" wide. Figure 11 shows the thickness of the floor, which was  $\frac{1}{2}$ " plywood, and the spacing between the floor and the ceiling of the galley below, which was approximately 2 inches. There was no penetration of the galley ceiling from overpressure nor from fragmentation of the subfloor above.

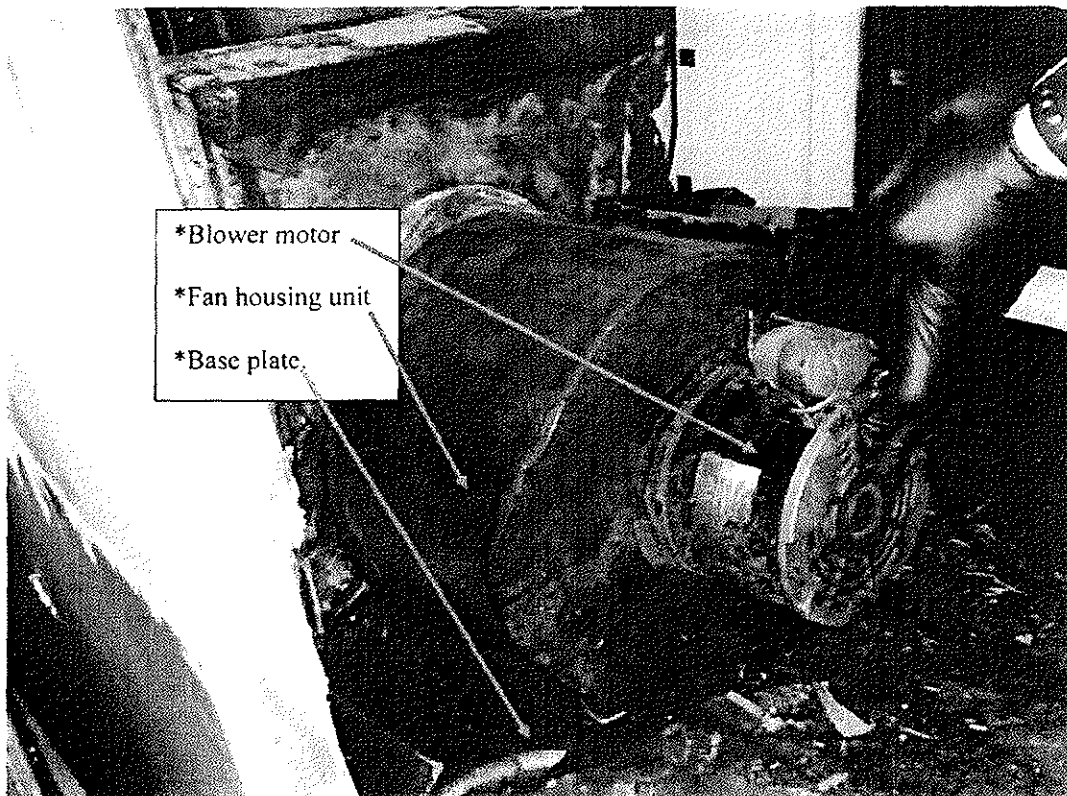
Figure 12 shows damage to the base plate and fan housing unit.

Item 25 consisted of a metal base plate or tray that had the blower motor, fan unit and radiator sitting on it. This plate had damage consistent with being in close proximity to an explosion.

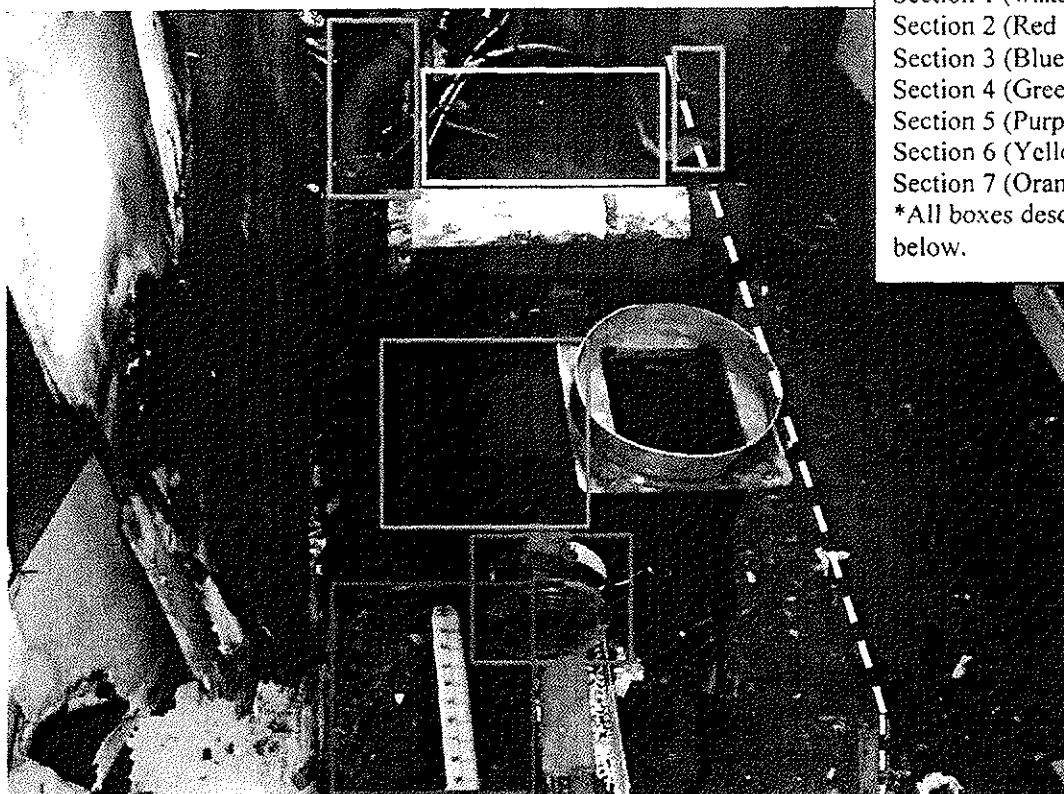
Section 1 (White dash line)  
 Section 2 (Red box)  
 Section 3 (Blue box)  
 Section 4 (Green box)  
 Section 5 (Purple box)  
 Section 6 (Yellow box)  
 Section 7 (Orange box)  
 \*All boxes described below.

Figure 13 shows an overview of how the air conditioner unit was located under the box seat area. The white line (section 1) is an approximate outline of the outer wall of the box seat that covered the air conditioning unit. The red box (section 2) indicates the black insulation covering two copper coolant lines that carried refrigerant from a storage tank to the air conditioning unit and back. The blue box (section 3) indicates the fan housing unit that sustained damage (see figure 12 for closer view of damage) from the blast. The green box (section 4) indicates the fan motor. The purple box (section 5) indicates the area of greatest damage. The yellow box (section 6) is where cleaning chemicals purportedly were stored along with other chemicals used on the boat for various maintenance purposes. To gain access to this area, screws would have to be removed from the lid of the box seat or the air intake grate. The approximate location of the air intake grate is indicated by the orange box (section 7).

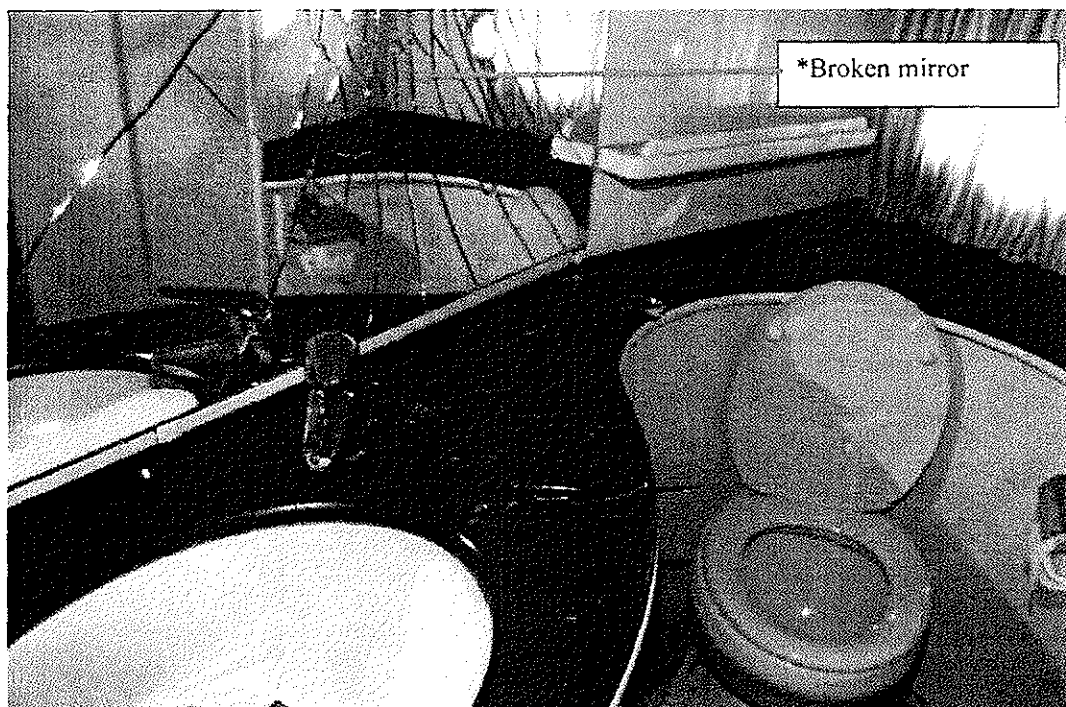
The lower deck directly below the area of greatest damage on the main deck sustained minimal damage; a broken mirror in the bathroom, (figure 14) and broken wood in the galley (figure 15).

Figure 14 shows the broken mirror in bathroom on the lower deck. This bathroom was located directly at the bottom of the stairs below the area of greatest damage.

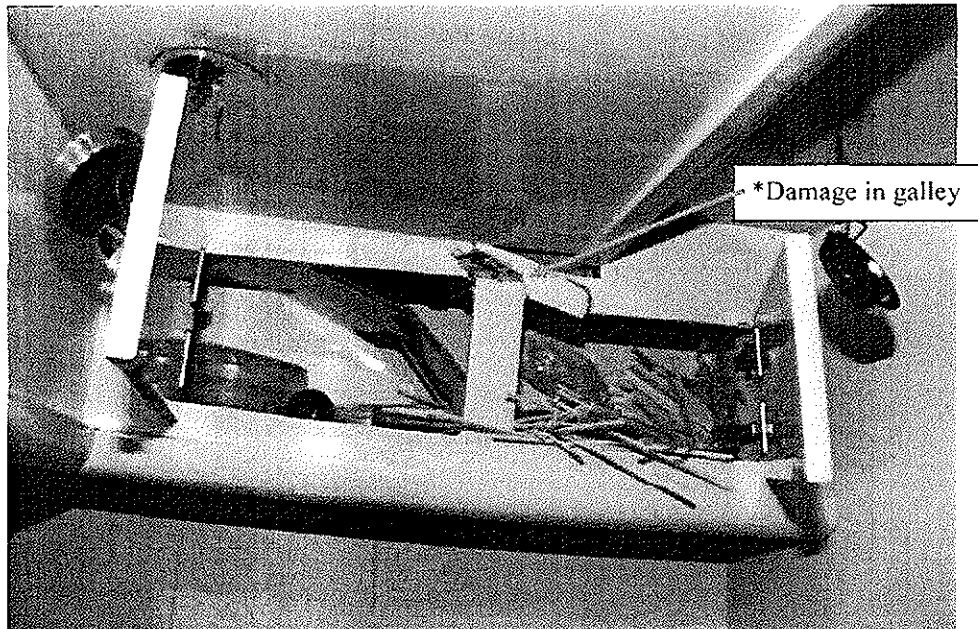
Figure 15 shows the damage to the wood cabinet in the galley. There was no penetration of the ceiling from the area of greatest damage above.

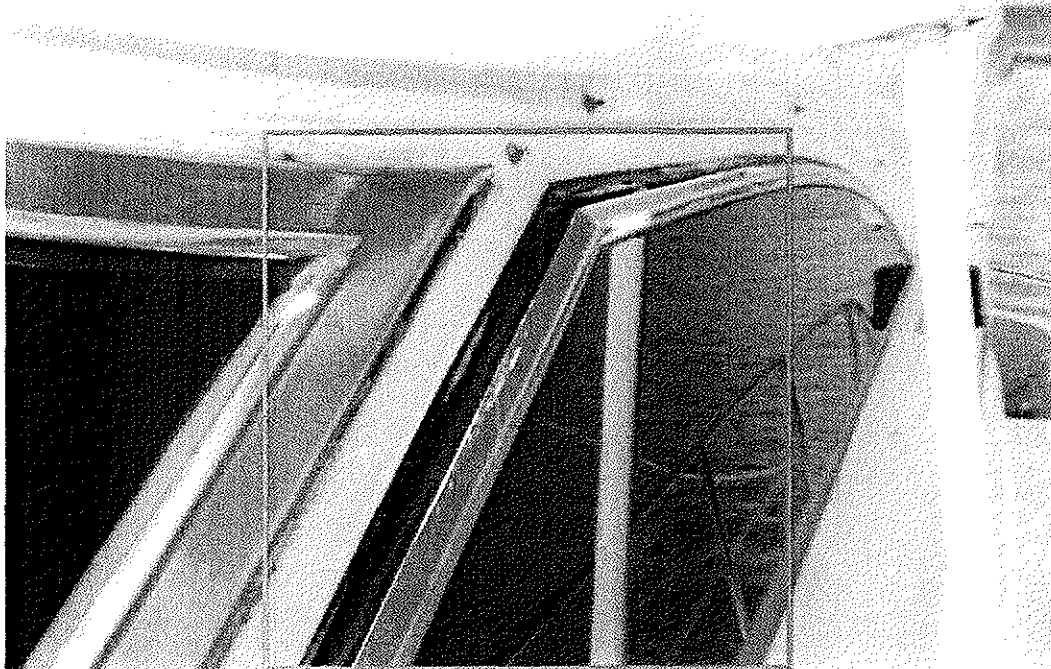
Figure 16

The exterior of the boat had no visible damage except a port side window (shown in the red box in figure 16) that was slightly pushed out from its frame due to the blast.
